FRACTOGRAPHIC ANALYSIS OF BROKEN CERAMIC DENTAL RESTORATIONS

G. D. Quinn
Volpe Research Center
American Dental Association Foundation
Stop 854-6, NIST
Gaithersburg, MD 20899

Ceramic Engineering and Science Proceedings, [1] (2015) 39-51.

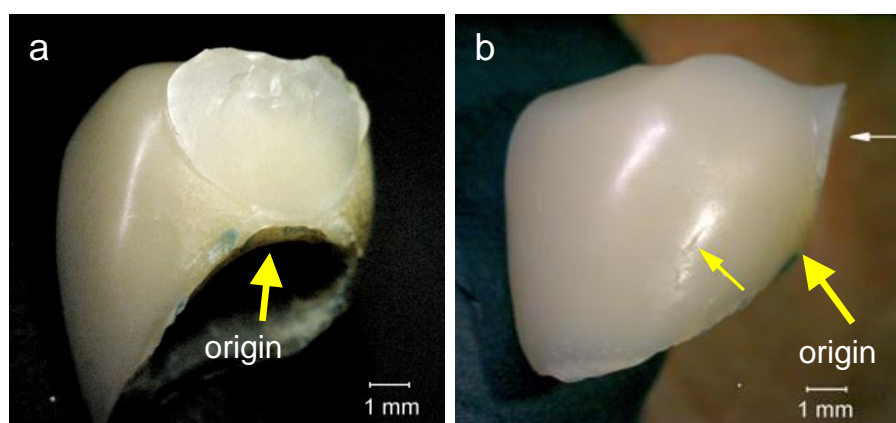
Figure 1 Case B1. Views of the fractured zirconia bridge. The origin was on the underside of the connector. A small medium-sized arrow in (b) shows a large sintering crack.

This Cercon CAM (computer assisted machining) prepared zirconia bridge fractured *in vivo* 2003. No documentation was furnished and only one piece was retrieved. Figure 1 shows that the fracture occurred at the connector to an end molar unit. The connector had a good cross section size. Figure 1b appeared in the Guide to Fractography as illustration (Figure 4.7a) of how a large sintering crack could be present in a ceramic, but not necessarily act as a fracture origin. Figure 2 shows the fracture surface and radiating hackle lines led back to the origin site. The origin was on the underside of the connector was grinding cracking that generated “machining crack hackle” once fracture occurred. These are described in detail in Refs. 11,12,13. They are much easier to see with a low power optical microscope (Figure 2a) than with the scanning electron microscope (SEM) (Figure 2b).

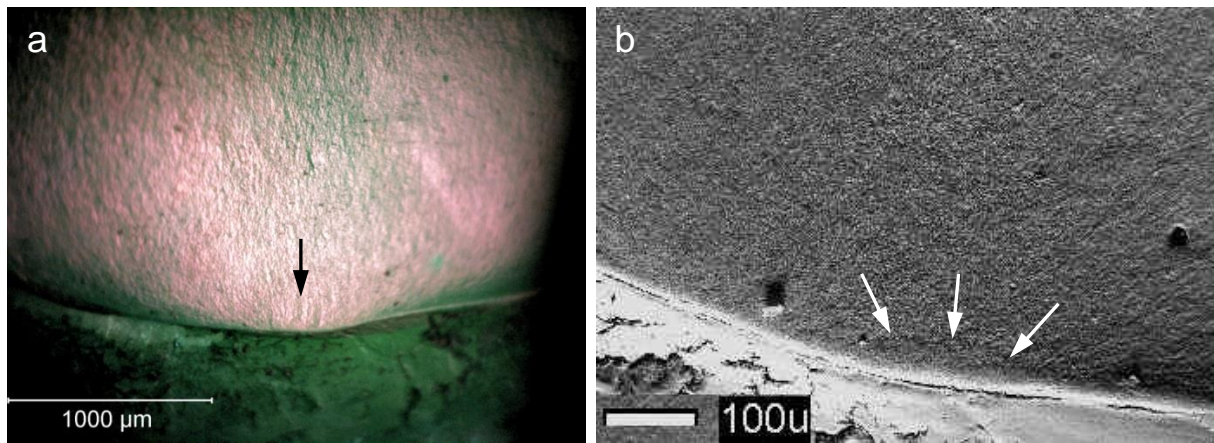
Figure 2. Case B1. Views of the origin site. (a) The low magnification optical image shows hackle leading back to the origin site as well as localized machining crack hackle at the origin itself. (black arrow). (b) Dr. J. Quinn used montages of many SEM photos to painstakingly create a map leading back to this site. She marked the origin grinding flaw with the arrows shown. The small steps and shadows in (a) are washed out by the SEM.

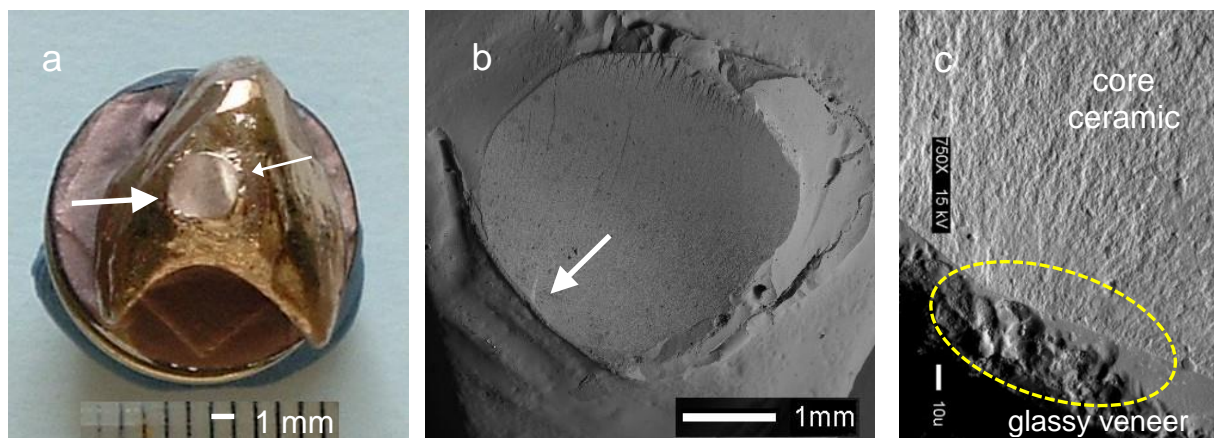
Figure 3. Case B2. A laboratory fractured zirconia bridge. (a) shows the gold-coated incisor end unit. The connector size is too small. The small arrow in (a) shows a compression curl. The large arrow shows the origin site. (b) shows the fracture surface and (c) shows the origin which is damage in the veneer (circled) that propagated a crack into the ceramic core.

This Cercon CAD zirconia bridge fractured in the lab in 2003 during fabrication training. Only an incisor end unit (Fig. 3) was available. The connector size (≈ 2 mm) was too small. The low magnification image (Figure 3a) shows a compression curl which is indicative of a bending fracture. The origin is located opposite to it. This bridge broke primarily from a sideways force probably from mishandling or possibly during the grinding. SEM images (Figures 3b,c) show the fracture surface is very smooth and almost featureless, indicative of a low energy, low strength fracture. The origin was microcracking and bubbles in the veneer. They combined to make a crack that propagated into the core. Additional SEM images (not shown) show the core crack progressed in stages with multiple concentric semielliptical arrest lines.

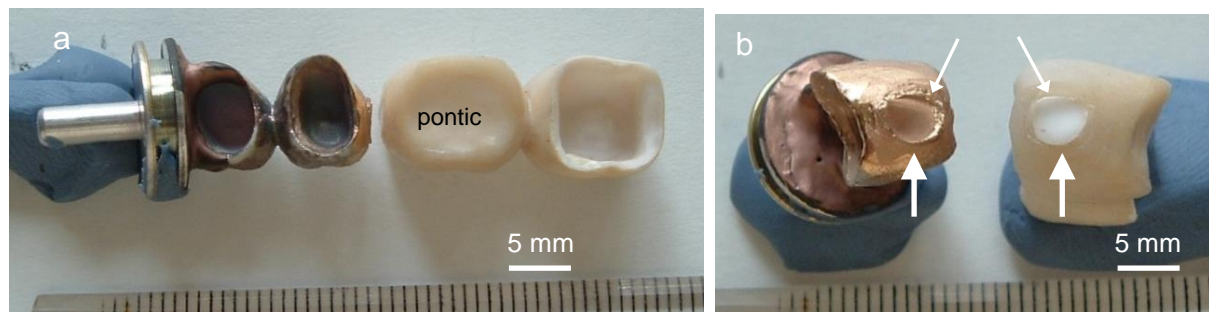
This also was a training course restoration. Figure 4a shows that this bridge was designed to be supported by three abutments. Fracture occurred at one connector to the pontic. This connector was too small. The location of the compression curl indicated that this bridge also broke from sideways flexure. It also was a low energy, low strength fracture. Optical photos in Figure 5 confirmed that the origin comprised irregularities in the veneer as well as “zipper machining cracks” in the core ceramic from machining.

Figure 4. Case B3: A four-unit posterior zirconia bridge in (a). The piece on the left is gold coated. (b) shows the fracture surfaces with the piece's occlusal surfaces mounted back-to-back. Compression curls are marked with small arrows. The origin is marked by the large arrows.

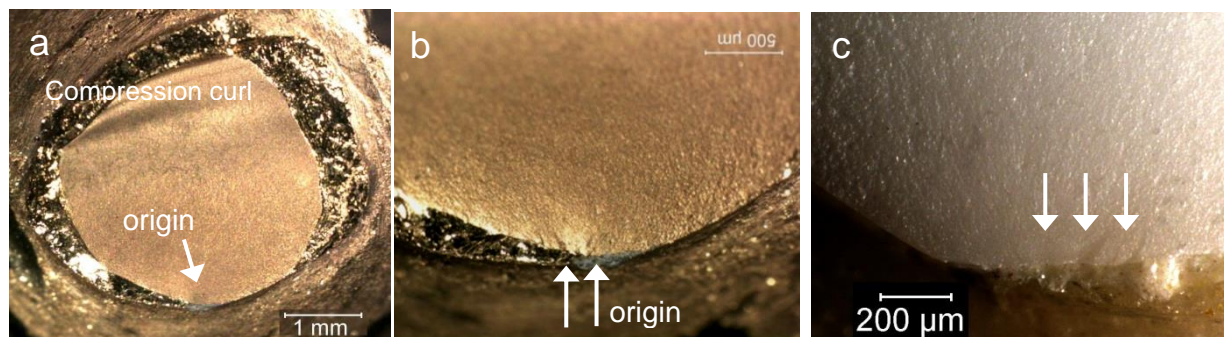
Figure 5. Case B3. Optical views of the fracture surface. (a) and (b) are gold coated. The origin is a series of small grinding cracks in the core that were covered by the veneer. Gold coating and vicinal shadow illumination make the “zipper machining crack” hackle lines easy to see with optical examination. They were not evident with high magnification SEM examination. (c) is a simple optical image of the uncoated fracture surface taken by Dr. J. Quinn in 2003 that also shows the grinding crack hackle and veneer irregularities.

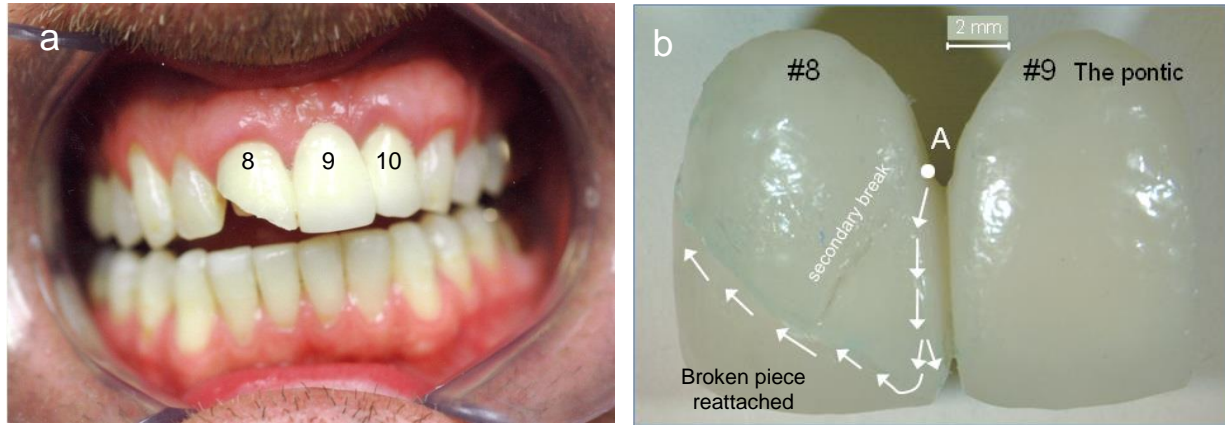
This was a three-unit anterior maxillary bridge, shown in Figure 6, which fractured at the connector to the right central incisor in mid-2009 after approximately four years in the patient's mouth. This case was presented in some detail in Ref. 9 and this case included here for comparison to the other bridge cases. The bridge was cemented to abutments on the end two units #8 and #10. The clinician who donated the broken FPD detected a crack in the incisor (#8) during a routine checkup and monitored its progress with time. When fracture occurred, he was able to retrieve units #8 and #9 on either side of the fracture plane. The clinician believed that the restoration was a zirconia, but our analysis showed that it was actually glass-infused alumina.

Figure 6. Case B4. The three-unit anterior maxillary bridge which broke through the side of the incisor unit #8 as shown in (a). Crack propagation occurred as shown by the arrows in (b). The triangular broken fragment was reattached for this photo.

Figure 6b shows a close-up with arrows marking the direction of crack propagation (dcp) away from the origin site A, which was on the margin. Figure 7 shows the fracture surface. The crack went down the side wall of #8 to the incisal edge. It then went around the restoration and caused a large triangular piece to break off. The origin region is shown in Figures 7a and 8. There were no severe material irregularities or gross flaws at the margin. The lack of a fracture mirror indicated the fracture stress was low. The margin was well-prepared and had a smooth rounded edge. Nevertheless, there is a small crack at the bottom, and combined with hoop stresses acting on the rim of the unit (presumably created by occlusal biting forces), the crack propagated up the thin wall of the tooth and split it. This is a failure mode that has been observed before in a number of single crowns, especially if they are very thin or if the margin is damaged during manufacture or installation. As a consequence, it is strongly advised to not use “knife-edge” or “feather” margins, which some clinicians like to use for aesthetic reasons. Such restoration margins are simply too vulnerable even if a strong ceramic is used.

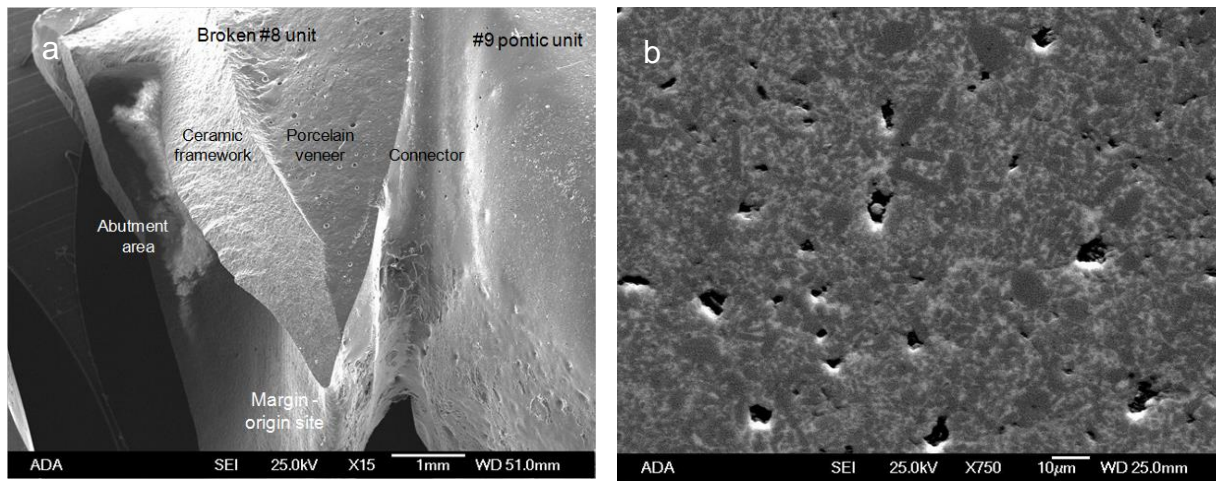
Figure 7b shows an SEM image of a polished portion of a fragment from core ceramic portion of the specimen. It is a two-phase material with residual porosity. The primary constituents were aluminum, calcium, lanthanum and silicon. This is not a zirconia restoration, but most likely that of a glass-infused alumina and is likely Vita Inceram alumina.

Figure 7. Case B4. (a) is a SEM image of the fracture surface on unit #8. The layered structure of a ceramic restoration is revealed. The thin tapered margin blends into the gum line and is the site of the fracture origin. This origin site is near to, but not at, the connector to the next unit, #9. (b) shows the core ceramic microstructure.

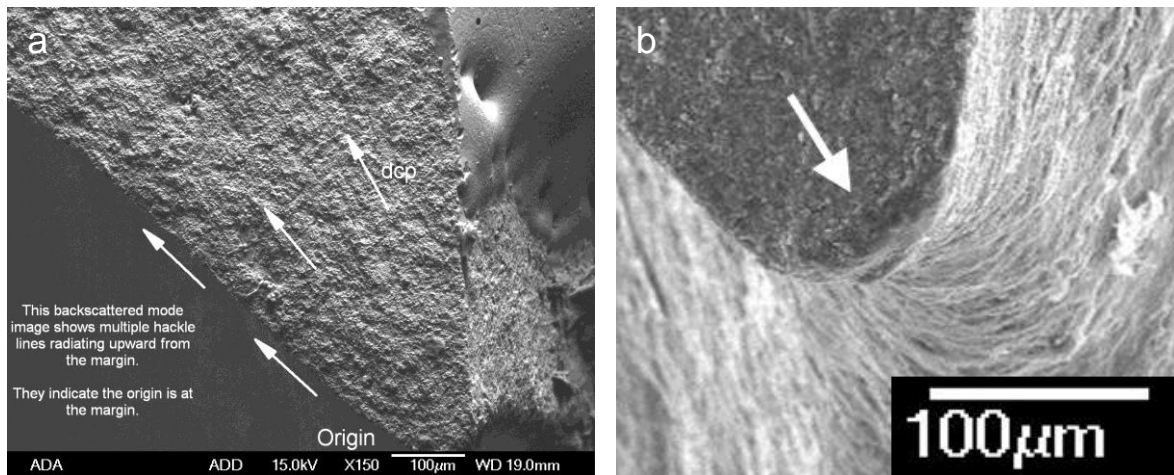
Figure 8. Case B4. SEM close-ups of the margin region showing hackle lines that indicate the dcp. Fracture started at the tip of the margin (large arrow on the right image). The margin is smooth and rounded and has no obvious faults, with the exception of a possible tiny crack.

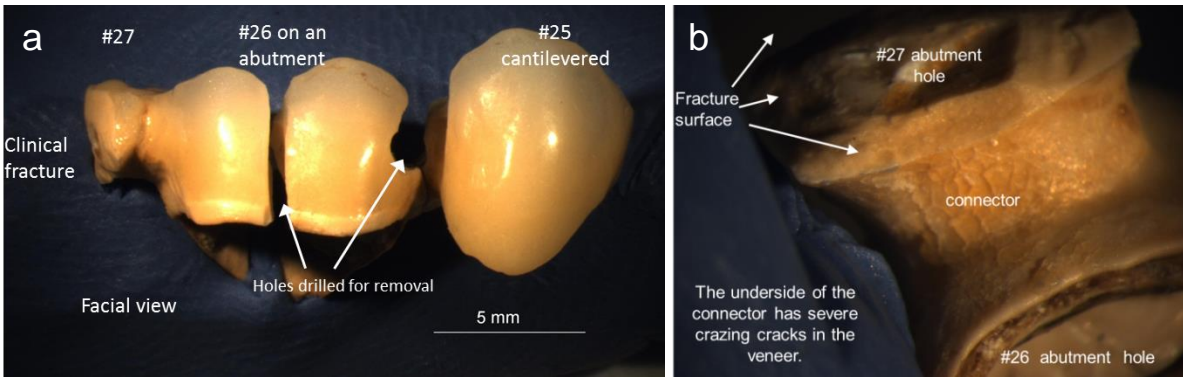
This was a three (or more) unit anterior bridge, shown in Figure 9, which fractured in European unit #25 near to but not at the connector in 2011 after 4 years *in vivo*. This case has not been documented previously. Only three pieces were obtained from one end of the restoration and the documentation was incomplete. Two of the three fragments were separated during extraction. The clinical fracture face was on the left on unit #27 as seen in the figure. Units #27 and #26 were fitted to abutments, but #25 was cantilevered. The restoration was prepared during a training course and was designed by an experienced elder dental technician, but fabricated by an unknown attendee in the course. The bridge framework was made with a Sirona copy milling machine. The fracture surface (Figs. 10 and 11) and the underside of the proximal connector (Fig. 9b) had very unusual markings. The veneer was badly crazed on the connector underside, indicating an improper composition or application, or improper furnace operation.

Figure 9. Case B5. Multiunit zirconia bridge. The underside of the connector and the fracture surface had very unusual features.

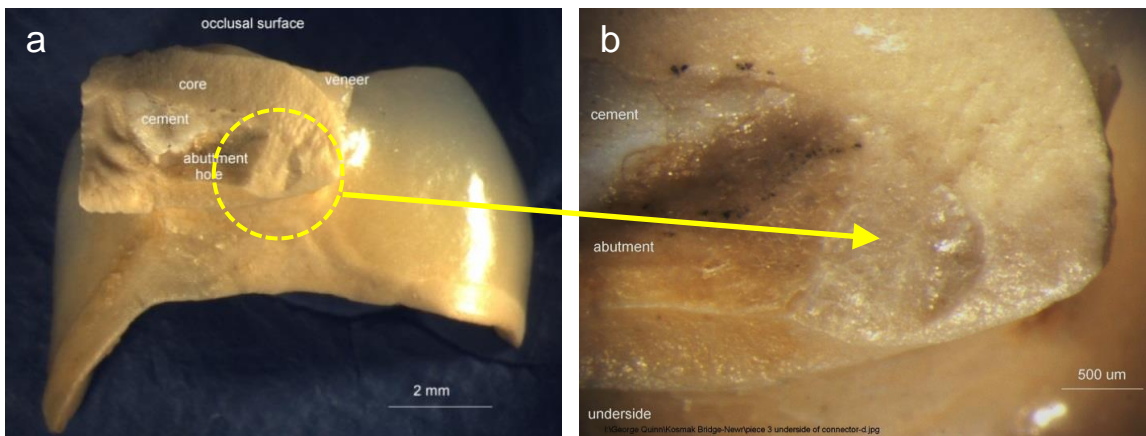
Figure 10. Case B5. Views of the fracture surface. Half of the fracture surface on either side on the bottom (circled) was extremely rough and the microstructure did not match that of the core material on the upper half of the fracture surface. Notice the glassy appearance of the material as shown on the right in the vicinity of the arrow tip.

No distinct fracture origin was detected, but on the basis of the extremely unusual fracture surface morphology and glassy structure of the framework material in the fracture site, it is believed that this bridge was cracked during a step in the fabrication process. Glassy material from the core and veneer “healed” the crack and the restoration survived *in vivo* for 4 years. One wonders whether the veneer crazing on the underside of the connector should have warned the technician or the clinician that something was amiss. The connector also was too small: measuring only 2 mm to 2.5 mm in height.

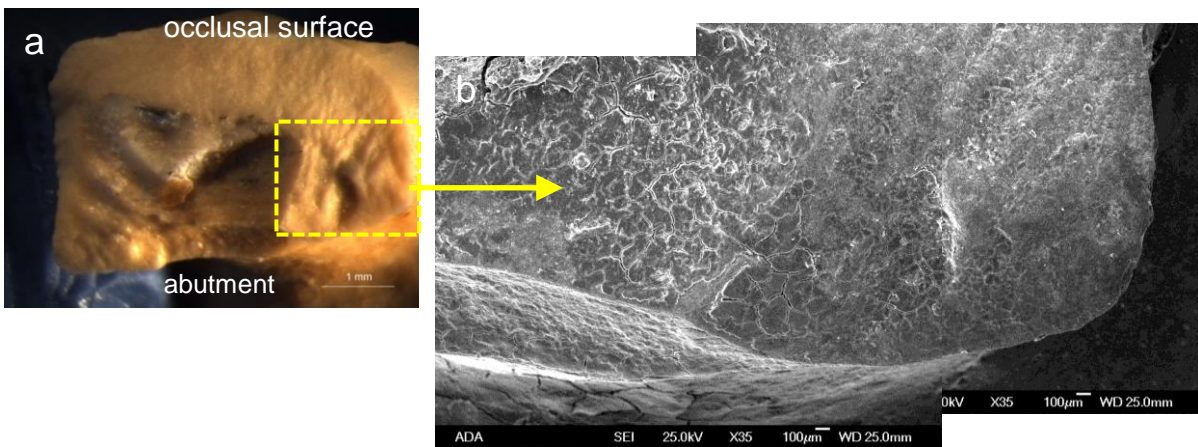
Figure 11. Case B5. Views of the fracture surface. (a) shows another view of how irregular the fracture surface was. (b) is a composite SEM image that shows the extraordinary crazing and cracking on the rough zone.

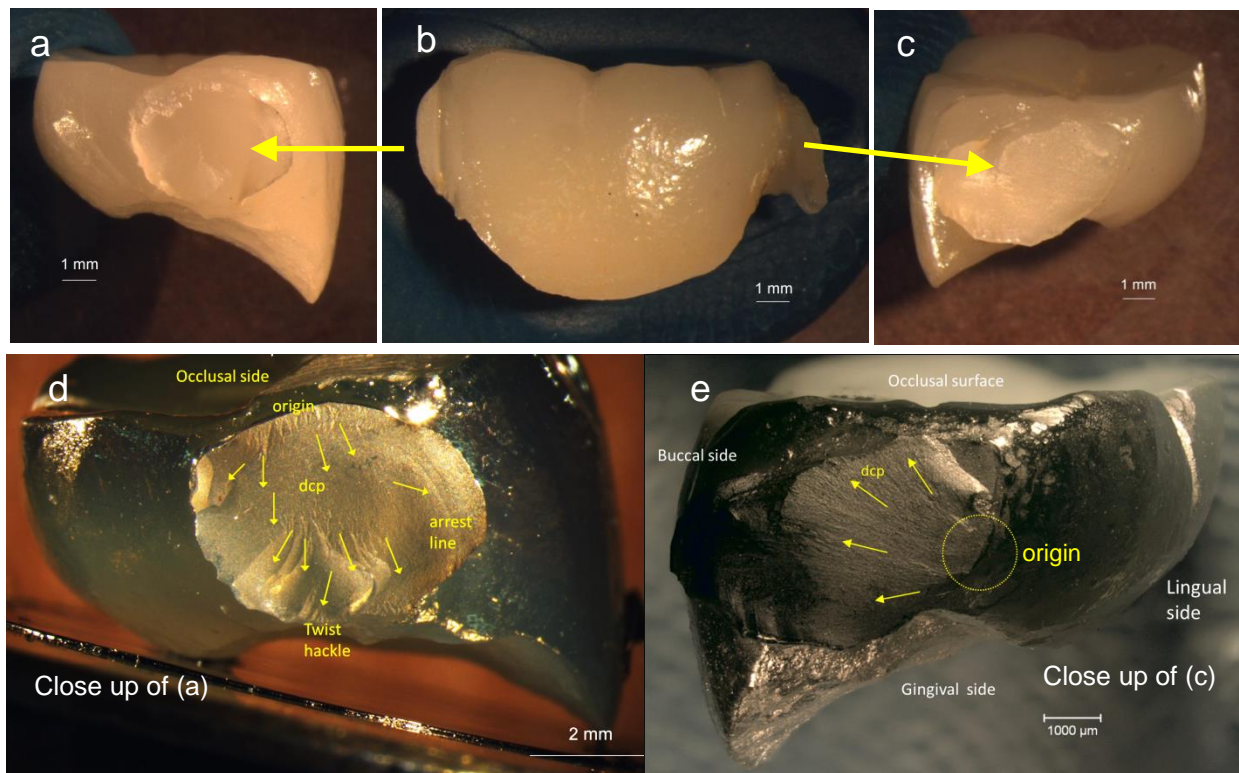
This three unit bridge broke in 2011 after seven weeks *in vivo* (Figure 12). When the patient was seen by the dentist, both connectors were broken, but the pontic section was still in place from mechanical interlocking. The connector shown on the right (Fig. 12c) fractured first, and continued occlusal loading and usage caused the second connector (Fig. 12a) to break from bending. Only the middle unit, the pontic was available for examination, but fortunately it had

Figure 12. Case B6. Middle molar unit of a three-unit bridge. The wing photos (a) and (c) show the fractured connectors on each side. (d) and (e) are close-ups of both broken connectors after gold coating. The right connector broke first and has a flatter and straighter fracture plane.

both fracture planes. The connector cross section sizes were probably too small for this glass ceramic. The secondary fracture started with an origin at the top. There was a lot of twisting and bending of this fracture surface, and this location suggested that this fracture was the second fracture. The primary origin was on the right side from the gingival-lingual area. Close-up examination (Figure 13) revealed that the origin was a single small contact damage site on the veneer outer surface. Cracking propagated in short steps through the veneer, and then into the core, also in a few steps until final catastrophic fracture occurred. Close-up photos of the contact site (not shown here due to space limitations) reveal classical tertiary Wallner lines and localized hackle radiation right at the contact site. Since it is down on the inside of the mouth, the patient would have had difficulty inflicting damage at this site. It is more likely that a dental probe or tool in the dental lab created the initial damage. This is an excellent example of a serious issue in ceramics: one small spot or vulnerable in a surface coating can act as a weak link. The core ceramic itself can be nearly perfect, with no flaws, but once the crack initiates in the coating, it can easily propagate into the bulk.

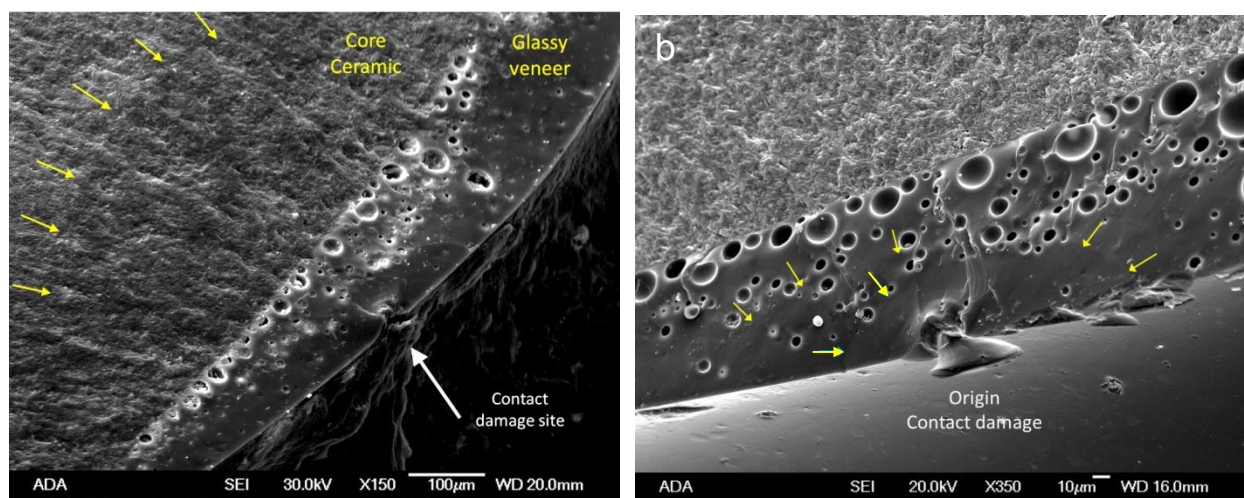
Figure 13. Case B6. SEM close ups of the origin. Radiating hackle lines converge on the origin region. The small arrows in (a) mark a subtle curved crack arrest line in the core ceramic, one of many such concentric arcs. Close-up examination of the origin in (b) reveals tiny wake hackle lines radiating behind the pores, and multiple arrest lines (marked by small arrows). Fracture initiated at the single contact damage site in the veneer outer surface, and propagated in steps through the veneer and then on into the core ceramic.

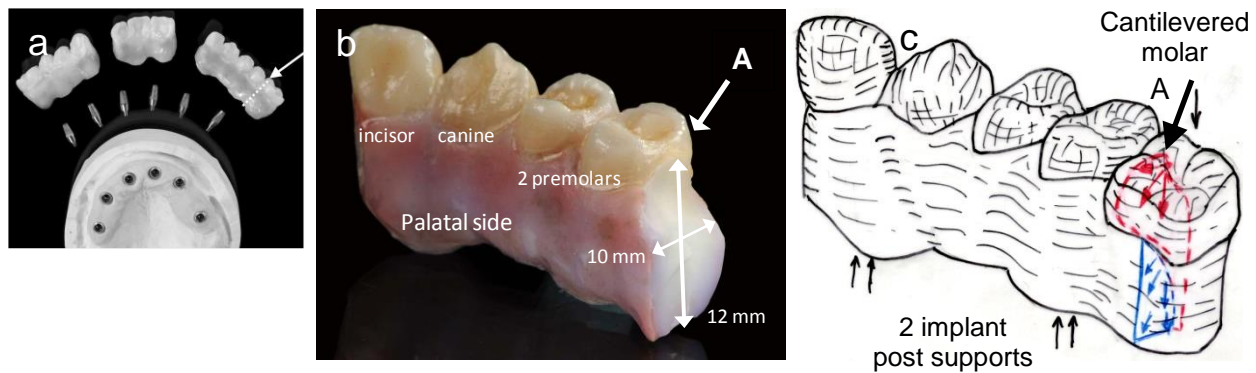
Three segments were used to replace the entire upper dental arch including substantial missing hard and soft tissues as shown in the left of Figure 14. This case has been presented in detail previously.⁹ Six implant posts supported the segments. The segment that fractured after installation was the five-unit telescoping denture made of a single large piece of veneered zirconia as shown in Figure 14a. It ran from the upper left lateral incisor to the upper left first molar and was attached to two screw implants that anchored the part at the incisor and second premolar teeth. The cantilevered end unit broke off the restoration in 2010 only 2 days after cementation. The patient exerted normal biting forces. This fracture was very surprising since the last molar was connected to the rest of the restoration by a very large 10 mm x 12 mm cross section. It is hard to imagine that a patient could apply sufficient biting forces to snap off such a

Figure 14. Case B7. Overall view of the fractured 5-unit denture. (a) is a laboratory view of the three segments comprising the maxillary arch with the location of the supporting screw implants. Fracture occurred (arrow) in the right side 5 unit segment where the last molar was cantilevered beyond the implant post. (b) and (c) show the fracture. The origin was at site A.

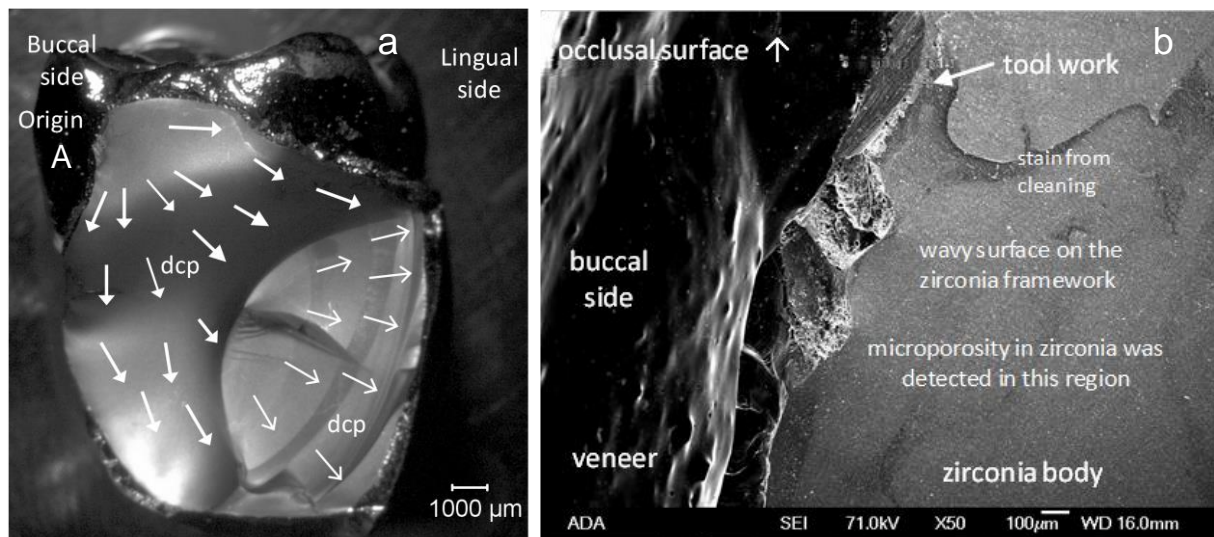
Figure 15. Case B7. Stereoptical microscope images of the gold-coated molar unit that broke off the end. The initial starting point of fracture is in the upper left in (a). A thermal crack popped in more than halfway through the piece as shown by the first set of arrows. Final fracture radiated in steps outwards towards the lingual side as shown by the second set of arrows. (b) shows a close-up of the origin site A. The core ceramic had some surface irregularities in the surface including waviness. The veneer also had grinding-adjustments that penetrated through the veneer into the core ceramic.

that popped in from origin site A during processing. The crack ran halfway through the piece and severely weakened it. The second fracture occurred when the end molar finally broke off in the patient's mouth. Close-up SEM examination of the origin shown in Figure 15b revealed irregularities in the core ceramic surface plus some grinding adjustment damage.

Very smooth, almost featureless, wavy fracture planes are commonly generated by thermal stress fractures. These can occur from: sudden temperature changes, thermal gradients set up by non-uniform heating or cooling, or internal residual stresses set up during firing. It cannot be ascertained with certainty whether the first crack formed during the cool down or after removal from the furnace. It is very likely that the veneer covered a cracked foundation piece or the crack may have popped in during the firing of the veneer.

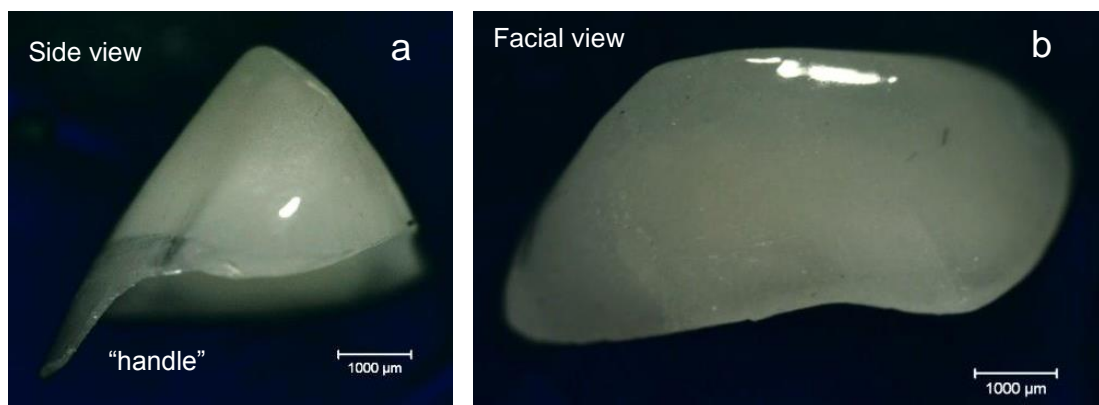
This case has nothing in common with the previous seven, with the exception that it too was a very unusual fracture. It was provided by the clinician from Vienna, Austria who dutifully reported the material system, the dental laboratory, the duration prior to fracture and the fact that it broke during normal bite functioning. Figure 16 shows the broken piece, which as subsequent analysis showed, was all porcelain veneer! It appeared that it completely detached from the core zirconia ceramic. Fractographic images with optical (Figure 17) and scanning electron microscopy (not shown) revealed that fracture started on the inside of the crown, about 0.5 mm below the outer crown surface. The fracture was entirely within the two layer veneer, and propagated entirely around the tooth without penetrating into the zirconia at all. The zirconia part of the crown remained in the mouth attached to the abutment, but had to be extracted and replaced. The veneer porcelain was primarily composed the usual elements of a feldspathic porcelain and included Si, Al, Ca, K, Fe but also a surprising amount of Cu. The origin crack, and especially its location, is very unusual and suggestive of a thermal crack possibly created during cool down. Figure 17c shows an extraordinary array of concentric semicircular cracks radiating outward from the origin. These are arrest lines and probably correlate with fatigue stepwise growth of the crack. This fracture sequence is similar to another veneered zirconia crown analyzed by Lohbauer in 2011.¹⁵ In that case, the crack popped into the veneer from occlusal surface contact damage, and then curved around the porcelain and the interface avoiding the zirconia core. There is steadily growing literature (e.g., Tholey et al., Ref. 16) showing that cool down rates through the glass transition temperature and thermal gradients in furnaces and restorations create strong residual tensile stresses in zirconia veneers.

Figure 16. Case C1. Detached porcelain veneer on the incisor crown that broke in-vivo at 14 months. The side extension of the crown is termed a “handle” for orientation convenience.

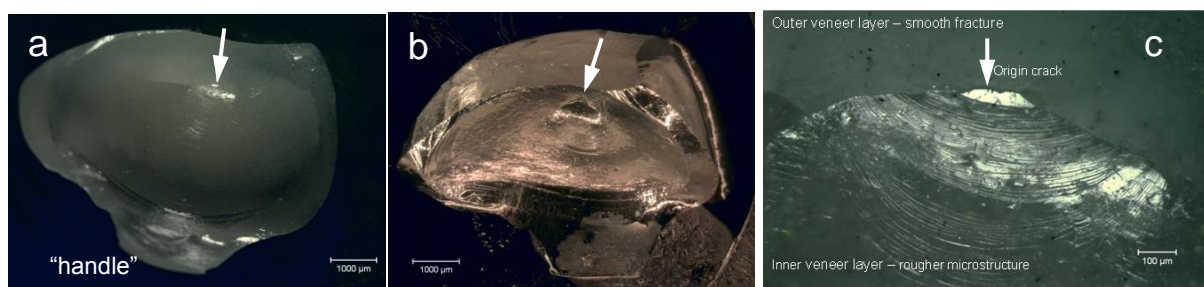
Figure 17. Case C1. Images of the interior surface. The fracture origin is an internal crack (large arrows) that started entirely in the outer veneer and then propagated into both porcelain layers in steps creating concentric arrest lines.
