FRACTOGRAPHY OF DENTAL RESTORATIONS

Susanne S. Scherrer^{1,a}, Janet B. Quinn² and George D. Quinn^{3,b}

Abstract. The dental community is using a variety of ceramic restorative materials such as porcelains (leucite or alumina based), glass-ceramics (leucite, mica, lithium disilicates), alumina-glass infiltrated, and CAD-CAM ceramics including pure alumina and zirconia (3Y-TZP) core materials. Polycrystalline ceramics such as alumina and zirconia serve as substructure materials (i.e., framework or core) upon which glassy ceramics are veneered for an improved appearance. Under masticatory loads, sudden fracture of the full-thickness restoration or of the veneering ceramic (chips) may occur.

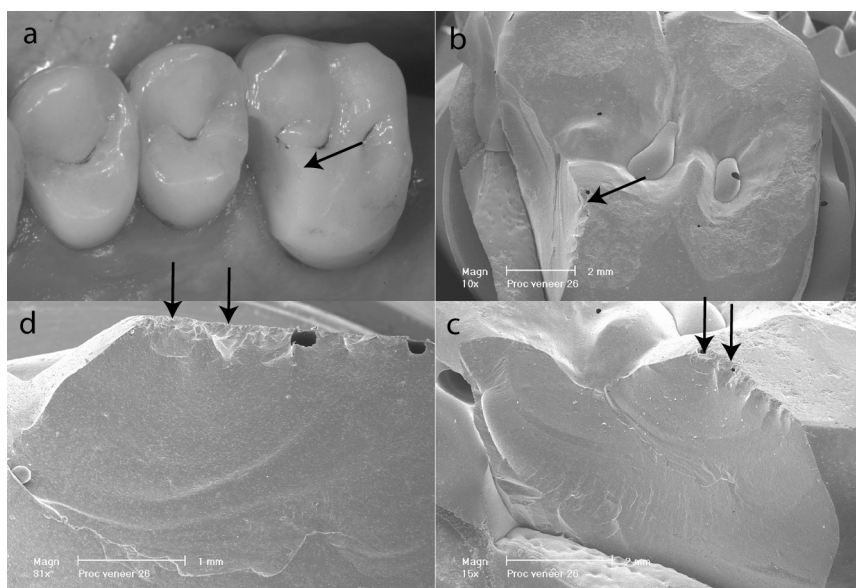
Case #1 (Fig.1): Procera®AllCeram (Nobel Biocare, Sweden) upper left molar crown with a veneer fracture after 4 years of intra-oral use. The replica shows evidence of important occlusal wear related to grinding habits (Fig.1b). The black arrows point to the origin, an area of high contact loading, located on the mesial-occlusal-palatal cusp. Arrest lines and hackle were clearly discernable on this replica (Fig. 1c,d). At higher magnifications (1000 X) wake hackle confirmed the general direction of crack propagation from the chewing surface downwards towards the gingiva.

Figure 1. Procera®AllCeram crown molar crown chip failure after four years (a). (b) shows a SEM view from a replica of the occlusal chewing side and the chipped surface. Important ceramic wear facets are visible on the occlusal surface at the level of the cusps. The fractured surface is represented in c,d, showing arrest lines and hackle. The black arrows point to the origin, located on the occlusal mastication surface.

The descriptive fractographic analyses of five ceramic veneer fractures as well as two through the thickness core fractures of clinically failed restorations identified the causes of failure and the origins. Thus, for all veneer chip failures, an origin located on the occlusal chewing side of the crown was identified. These veneer chip failures are due to a combination of problems. First, the glassy veneering ceramic is rather weak with low fracture toughness (i.e., $\approx 1 \text{ MPa}\sqrt{\text{m}}$) and low flexural strength ($\approx 100 \text{ MPa}$). Second, the veneering ceramic should be fully supported in all three dimensions by the stronger and tougher core materials such as alumina or zirconia. This is not always the case as these restorations have to be created in the laboratory with a perfect knowledge of the anatomical volume that is being restored. If too much veneering ceramic exists without an adequate core support, a crack may easily propagate under every day peak loading events. Third, the chewing paths and pressure on the restoration under function have to be perfectly adjusted by the clinician so that no overloading may occur. Veneer chips unfortunately result most of the time from a combination of one or all of these problems that have been insufficiently taken into consideration. The lessons learned from these chip failures are: 1) emphasize to the dental laboratory that correct three-dimensional constructions of the core materials are needed in order to properly support the veneering ceramic and, 2) dentists should carefully check the clinical contact loading points on the restoration during function and erase those located in critical areas such as the marginal ridges.

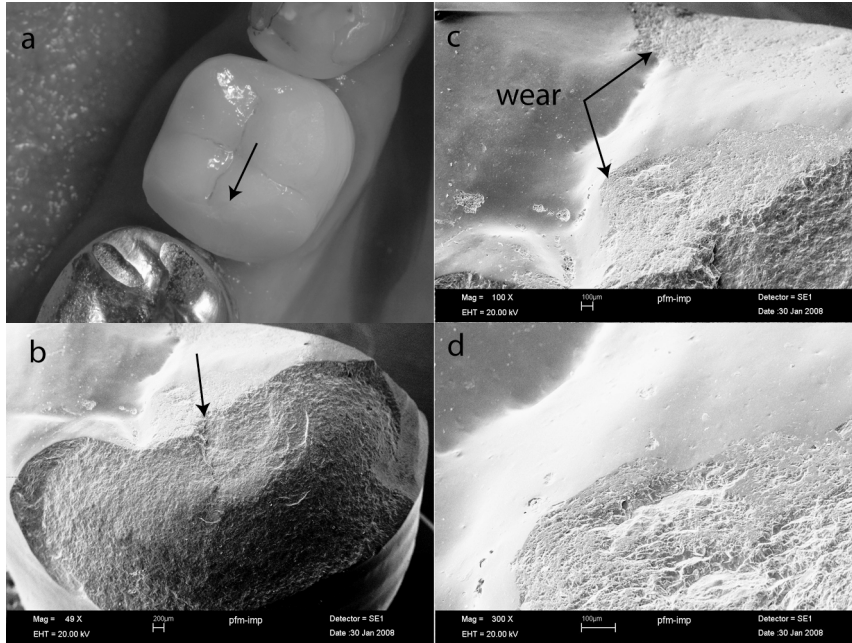
Case 2 (Fig. 2): Chipping after one year of the feldspathic porcelain of a porcelain-fused-to-metal crown cemented over a dental implant (Fig. 2a). The SEM image was taken directly on the recovered crown. A compression curl is visible in form of a shoulder on the outer contour of the broken surface (Fig. 2b). The crack origin (black arrow) is located on the occlusal (i.e. chewing) surface next to a contact wear area as seen at higher magnifications in Figs. 2c,d.

Figure 2. Porcelain-fused-to-metal chip failure after one year. (b) is a SEM image of the retrieved crown at low magnification and shows a compression curl on the bottom and sides of the photo in the form of a shoulder on the outer contour of the broken surface. The crack origin as indicated by the black arrow is located on the occlusal (i.e., chewing) surface next to a contact wear area (c,d).

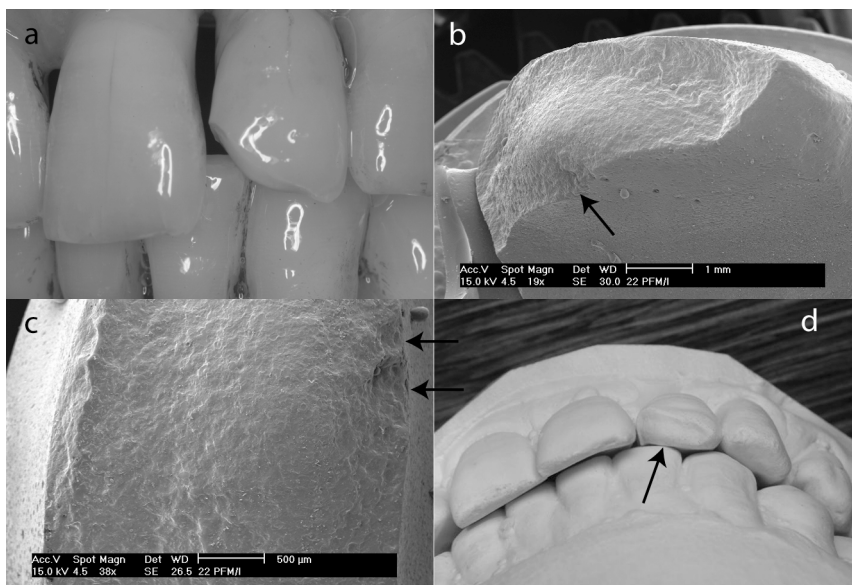
Case 3 (Fig. 3): Chipping after 2 months of the feldspathic porcelain of a porcelain-fused-to-metal crown on a lateral incisor, cemented over a dental implant. The SEM images (Figs. 3b, 3c) were taken from a replica. A compression curl is visible in form of a shoulder on the outer contour of the broken surface. The crack origin (black arrows) located on the palatal (i.e., chewing) surface shows two blunt indents resulting from contact damage with the lower incisor (Fig. 3d, black arrow)

Figure 3. Fracture of the veneering ceramic of a porcelain fused to metal lateral incisor restoration. The SEM images in (b,c) obtained from a replica of the fractured surface, show a compression curl in form of a shoulder (on the opposite side away from the arrows) and two blunt indents (black arrows) corresponding to the fracture origin and resulting from contact damage with the lower incisor (d, black arrow).

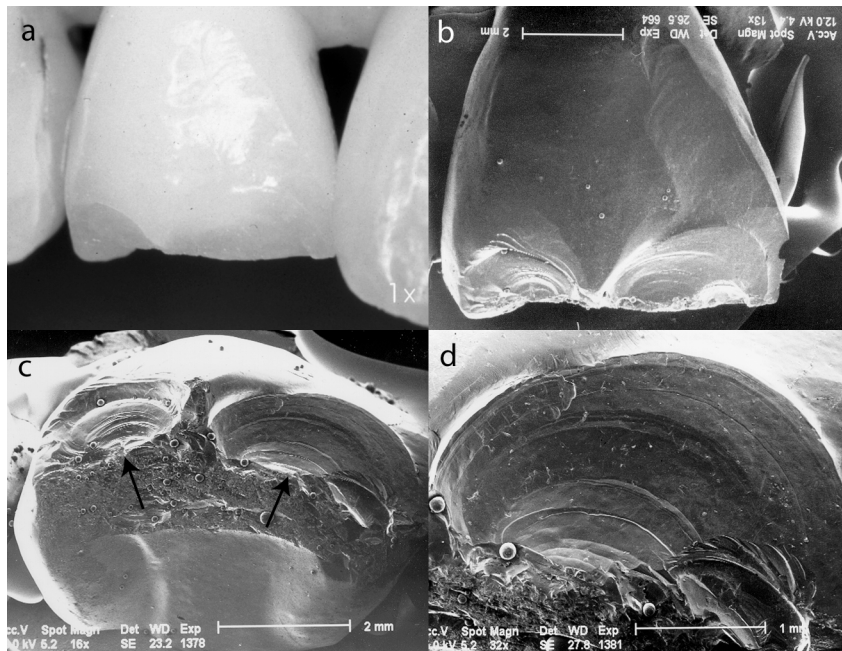
Case 4 (Fig. 4): Chipping of the aluminous porcelain veneer of a Cerestore® lateral incisor crown after 58 months in service. The SEM images obtained from a replica show two major fracture facets including many arrest lines and hackle. The important palatal wear surface of the entire incisal edge is directly in contact with the origins (black arrows), and indicates major grinding habits with the lower teeth.

Figure 4: Chipping of the aluminous porcelain veneer of a Cerestore® lateral incisor crown after 58 months in service. The SEM images (b,c,d) obtained from a replica show two major fracture facets including many arrest lines and hackle. The important palatal wear surface of the entire incisal edge is directly in contact with the origins (black arrows), and indicates major grinding habits with the lower teeth.

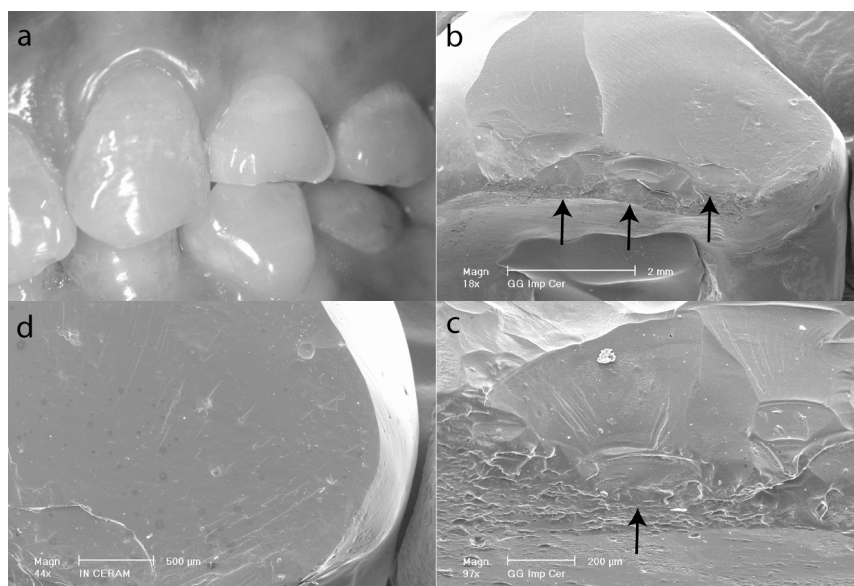
Case 5 (Fig. 5): Veneer ceramic edge chip of an In-Ceram Zirconia premolar crown, screwed over a titanium dental implant. The fracture occurred after 2 months of intraoral service. The SEM images are taken from a replica. Clear signs of wear at the incisal edge are visible (Figs. 5b,c), followed by several arrest lines. Multiple origins (black arrows) are seen located along the fractured edge (Fig. 5d) indicate the general direction of crack propagation running from the incisal edge (bottom of image) upwards, towards the gum.

Figure 5. Veneer ceramic fracture of an upper first premolar. Hackle and wake hackle (d) indicate the upwards direction of propagation. Several origins (black arrows) are located along the fractured edge (b). (c) is a higher magnification of (b) and shows a detailed region of the fractured edge near the first left arrow and contact wear, arrest lines, and hackle are seen.

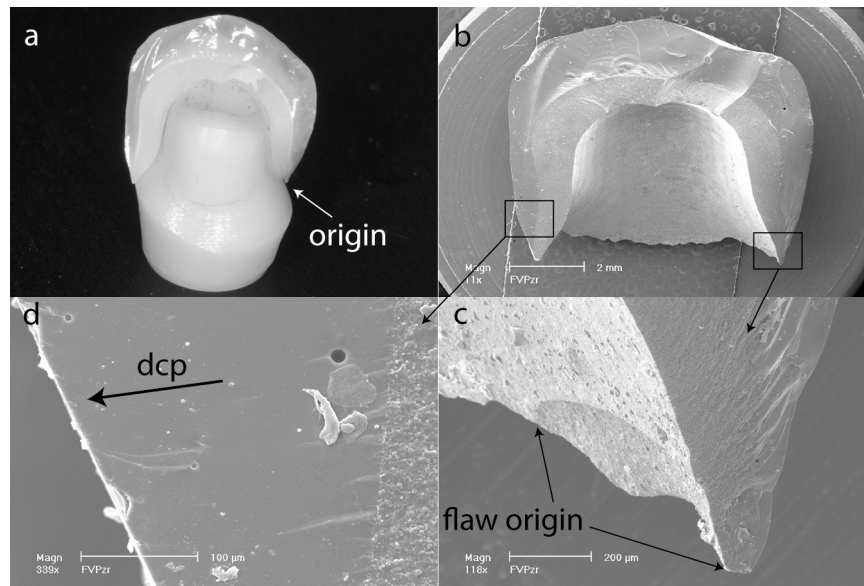
Case 6 (Fig. 6): Try-in failure through the alumina core of a Procera®AllCeram premolar crown over a zirconia implant abutment. The recovered fractured part (Fig. 6a) was analyzed in the SEM and showed many beautifully recognizable fractographic features such as hackle, wake hackle, arrest lines and compression curl. The flaw origin was located on the distal crown margin (lower right) as seen in Fig. 6c. The glassy composition of the veneering ceramic nicely reveals wake hackle (Fig. 6d) running outwards in the local direction of crack propagation (dcp) on the compression curl side. Additional damage then occurred on the inner crown surface of the alumina core as a result of the crushing impact with the zirconia abutment while the crown was breaking from the first crack and the patient kept pressing on the crown vertically (top of Fig. 6b). The primary cleavage plane runs from bottom right (distal margin) to left (mesial) (Figs. 6a,b).

Figure 6. Procera®AllCeram alumina core crown with its glassy veneering ceramic positioned over a zirconia implant abutment (a). A compression curl (left side) as well as arrest lines and hackle are clearly visible on the SEM overall image (b). A higher magnification of the lower right margin (c) shows the critical flaw that caused the failure. On the opposite margin (left) a higher magnification (d) shows several wake hackle lines within the glassy veneering ceramic confirming that the direction of crack propagation (dcp) was outwards on the side of the compression curl.

The fracture of the alumina crown during try-in (case 6) was a surprise as it came during the occlusal adjustment session with a patient using moderate biting force. The location of the origin at one margin can be explained by the fact that the alumina core was only $100 \mu\text{m}$ thick at the margins, which is an area of maximum tensile stresses, and that the crown was not yet cemented to the zirconia implant abutment during the biting adjustments. The lessons learned from this case are:

1) the core margins should be designed to be as thick as possible, and 2), dentists should permanently cement the crown onto the implant abutment before the final occlusal adjustments in order to reduce the stress concentration within the margins.

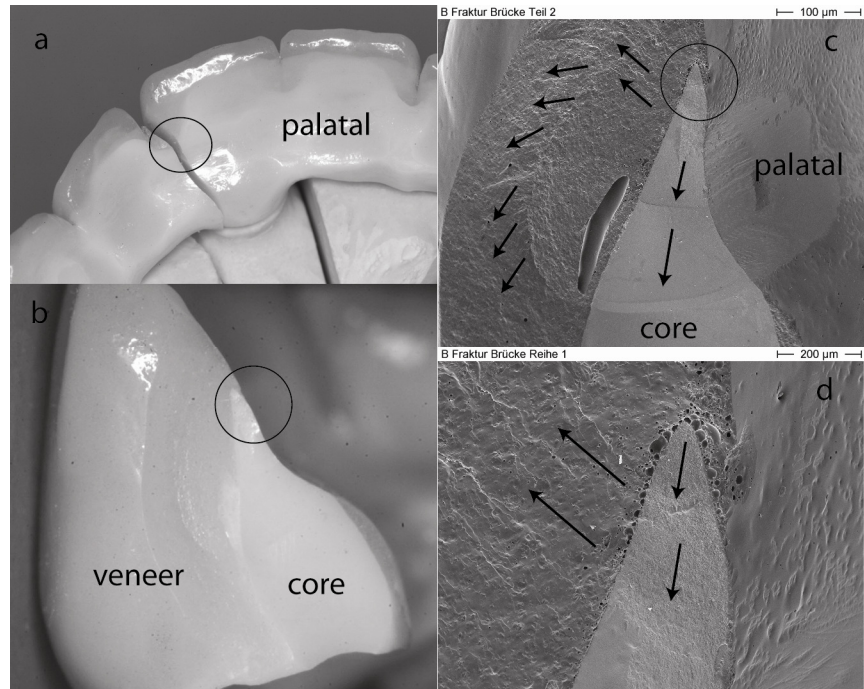
Case 7 (Fig. 7, next page): Fracture of a Cercon (Y-TZP) zirconia 6-unit bridge after 24 hours of intraoral use. The fracture through the core occurred at the connector between the central incisor and the lateral incisor (Figs. 7a,b). The low magnification SEM image (c) shows arrest lines within the zirconia core as well as hackle and wake hackle within the veneering ceramic indicating the direction of crack propagation as marked by the black arrows. Figure 7d is a higher magnification of the circled area in Fig. 7c representing the tip of the zirconia core surrounded by a cluster of pores within the veneering ceramic at the interface. This was starting point of the critical crack which then propagated downwards and outwards (black arrows).

Figure 7. Fracture of a Cercon (Y-TZP) zirconia 6-unit bridge. The fracture through the core occurred at the connector between the central incisor and the lateral incisor (b). The low magnification SEM image (c) shows arrest lines within the zirconia core as well as hackle and wake hackle within the veneering ceramic indicating the direction of crack propagation as marked by the black arrows. (d) is a higher magnification of the circled area in (c) representing the tip of the zirconia core surrounded by a cluster of pores within the veneering ceramic at its interface. This was starting point of the critical crack while it propagated downwards and outwards (black arrows). Original images are the courtesy of Dr. Ulrich Lohbauer (Univ. of Erlangen, Germany)

Finally, the connector fracture of the 6-unit zirconia bridge (case 7) showed several design problems. First, the zirconia core framework was anatomically wrongly designed in a drop shape that was not proportional to the volume to be replaced. Second, the whole zirconia framework was located too much on the palatal side, with a direct exposure to the occlusal contact surface with not enough space for the veneering ceramic. Third, the tip of the zirconia framework was so thin (100-200 μm) that the application the veneering ceramic was flawed so that there were many pores at the interface. This weakened the structure in an area exposed to chewing and pressing forces which created stress concentrations at the tip of the zirconia frame. The construction of a six-unit bridge involving many working hours, this fracture case should serve as a teaching lesson for laboratories to emphasize the importance of design issues as well as for clinicians to learn to recognize faulty design frameworks from laboratories.
