# Laboratory Simulation of Y-TZP All-ceramic Crown Clinical Failures

Article in *Journal of Dental Research* · May 2009

*J Dent Res* 88(4):382-386, 2009

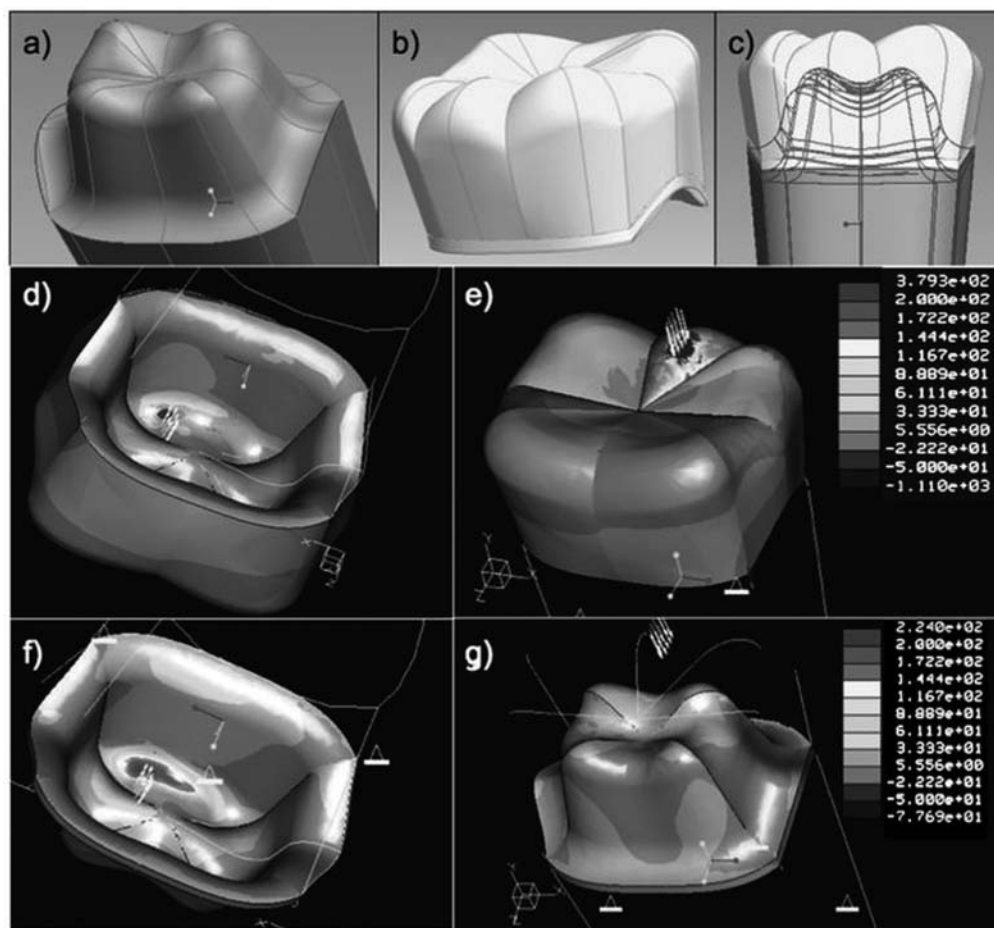
**Figure 1.** Finite element analysis results. **(A)** CAD-designed four-cusp right first molar preparation and **(B)** cement, zirconia core, and veneer solid models. **(C)** Assembled preparation, cement, zirconia core, and veneer solid models. **(D,E)** Resulting maximum principal stress obtained on the veneer solid under a 1200-N vertical load applied on the mesial-distal cusp of the veneer solid; and **(F,G)** resulting maximum principal stress obtained on the zirconia core solid under a 1200-N vertical load applied on the mesial-distal cusp of the veneer solid. Note the high maximum principal stress values observed in the bottom part of the zirconia core layer **(F)** at the region immediately below the load, and at the cervical region.

An anatomically correct 3-D CAD model of a mandibular first molar posterior tooth full-crown preparation and bilayer all-ceramic crown was generated. The solid components of the crown system consisted of a veneer layer (porcelain), a core layer (zirconia) of uniform thickness (0.5 mm), a 100- $\mu$ m-thick cement layer (resin cement), and a tooth preparation (dentin) created in CAD software (Pro/Engineer Wildfire, PTC, Needham, MA, USA) (Figs. 1a, 1b). The components were assembled (Fig. 1c), imported into FEA software (Pro/Mechanica, PTC, Needham, MA, USA), meshed (~ 16,000 tetrahedral elements), and tested for convergence prior to mechanical simulation.

The FEA model assumptions were that: (1) all solids were homogeneous, isotropic, and linear elastic; (2) there were no slip conditions (perfect bonding) among components; (3) there was a uniform cement layer (elastic modulus,  $E = 8$  GPa, and Poisson's ratio,  $\nu = 0.33$ ); (4) there was a 0.5-mm zirconia core thickness ( $E = 205$  GPa,  $\nu = 0.19$ ); (5) there was a five-cusp porcelain veneer layer ( $E = 70$  GPa,  $\nu = 0.19$ ) 1 mm thick on the axial walls and 1.5 mm thick on the occlusal surface; (6) there was a dentin tooth core ( $E = 16$  GPa,  $\nu = 0.33$ ); (7) there were no flaws in any components; and (8) there was a six-degrees-of-freedom (full) constraint on the root component surface. Loads were applied over a 1-mm-diameter circle, simulating a typical occlusal contact area, at the mesial-distal

Variations in maximum principal stress developed on the crown veneer and zirconia core solids (Figs. 2d-2g). High stress levels were observed directly below the load region for both veneer and zirconia core solids (Figs. 2d-2g), and higher stress levels were observed at the zirconia core region in contact with the cement layer. Increased levels of stress concentration were also observed at the margin regions of the zirconia core, including proximal regions (Figs. 2f, 2g).

The finite element analysis output for the zirconia core-veneer system under a load of 1200 N (near the average force observed in single load-to-fracture) showed high stress concentrations in both veneer and zirconia core solids. This is in agreement with the site of crack initiation of the single load-to-fracture crowns that failed through the zirconia core, but not with those tested in fatigue, which failed cohesively in the veneer layer (clinically observed critical failure mode) (Sailer *et al.*, 2007).

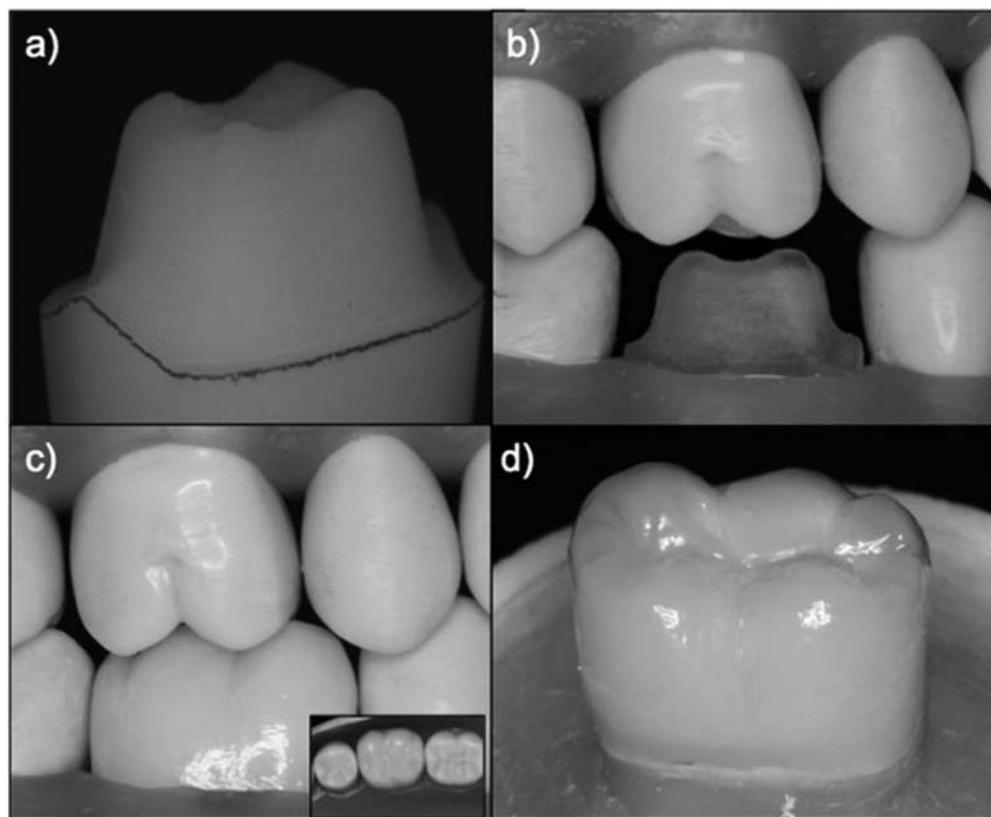
**Figure 2.** Crowns made from the anatomically correct crown model. **(A)** Plastic prototype of the prepared tooth, **(B)** plastic prototype inserted into a dental arch and articulator, **(C)** all-ceramic crown with 0.5-mm zirconia core **(D)** crown cemented onto plastic prototype, embedded in acrylic resin in preparation for load testing.

Seventeen anatomically correct crowns were fabricated based on the design used in the finite element analysis described above. The CAD file of the prepared tooth was converted to \*.igs files, imported into a milling machine, and plastic models were generated (Fig. 2a). The plastic models were placed in a dental articulator (Fig. 2b) with opposing and adjacent dentition. Impressions of the prepared, adjacent, and opposing teeth were taken (Aquasil, Dentsply, York, PA, USA) and sent to a CAD/CAM milling center (3M/ESPE, St. Paul, MN, USA), where 0.5-mm-thick zirconia cores (LAVA, 3M/ESPE) were fabricated. These cores were veneered with porcelain (LAVA Veneer, 3M/ESPE) by a commercial dental laboratory (Marotta Dental Studio, Huntington, NY, USA), creating crowns with clinically appropriate fit and geometry (Fig. 2c).

The crown-tooth replica was embedded in acrylic resin (Orthoresin, Degudent, Mainz, Germany) in a 1-inch-diameter PVC tube. The crown buccal margin was placed 2 mm above the surface of the resin, with the long axis of the crown-tooth replica and tube aligned (Fig. 2d). Specimens were stored in water.

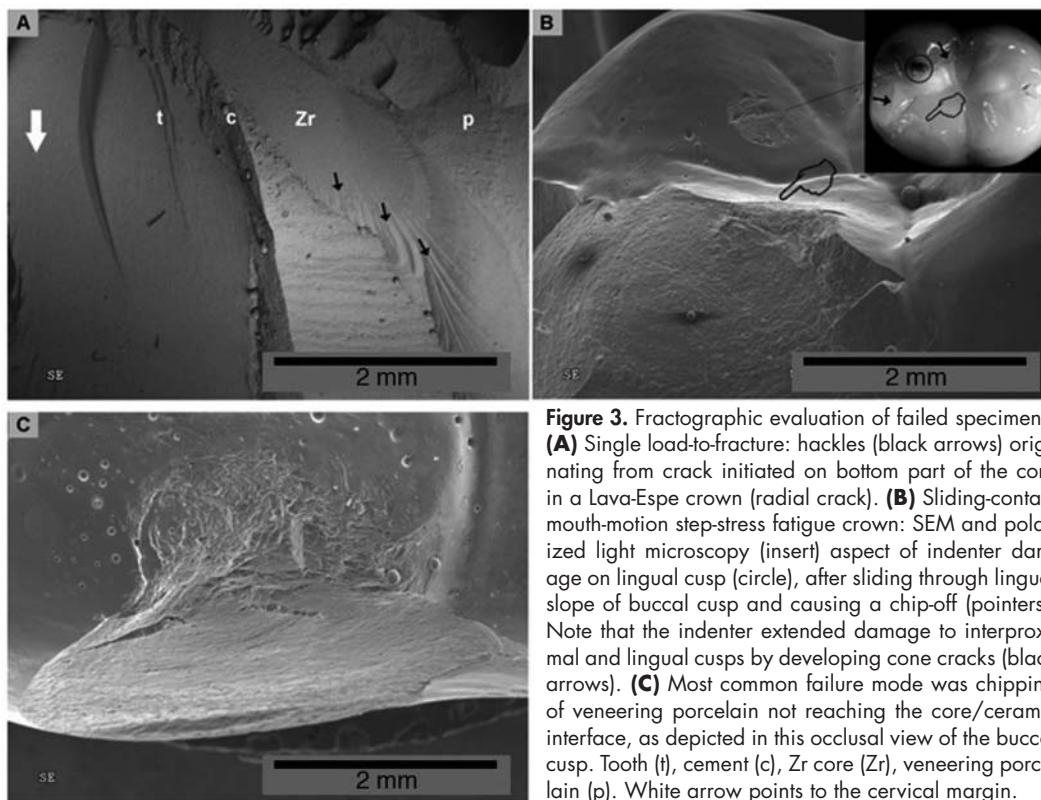
**Figure 3.** Fractographic evaluation of failed specimens. **(A)** Single load-to-fracture: hackles (black arrows) originating from crack initiated on bottom part of the core in a Lava-Espe crown (radial crack). **(B)** Sliding-contact mouth-motion step-stress fatigue crown: SEM and polarized light microscopy (insert) aspect of indenter damage on lingual cusp (circle), after sliding through lingual slope of buccal cusp and causing a chip-off (pointers). Note that the indenter extended damage to interproximal and lingual cusps by developing cone cracks (black arrows). **(C)** Most common failure mode was chipping of veneering porcelain not reaching the core/ceramic interface, as depicted in this occlusal view of the buccal cusp. Tooth (t), cement (c), Zr core (Zr), veneering porcelain (p). White arrow points to the cervical margin.

failure mode observed for all but one single load-to-fracture specimen showed a radial crack propagating from the zirconia core region in contact with the cement surface (Fig. 3a), resulting in a catastrophic failure fracture mode, including both the veneer and zirconia core (Fig. 3a). The fracture extended from the cusp ridge all the way through the zirconia cervical margin and cement layer. One single load-to-fracture specimen exhibited a cohesive veneer fracture similar to those observed in sliding-contact mouth-motion step-stress fatigue (Figs. 3b, 3c). Based on the mean single load-to-fracture, the maximum load for sliding-contact mouth-motion step-stress fatigue profiles was set at 600 N.

In total, 14 crowns were utilized for the sliding-contact mouth-motion step-stress fatigue testing: 8 specimens on Profile 1, 4 on Profile 2, and 2 on Profile 3. All 14 specimens failed cohesively within the veneer layer (Fig. 3). This cohesive fracture originated in regions directly below the indenter sliding path (Figs. 3b, 3c). In only one specimen did the fatigue fracture extend to include the veneer-core interface.

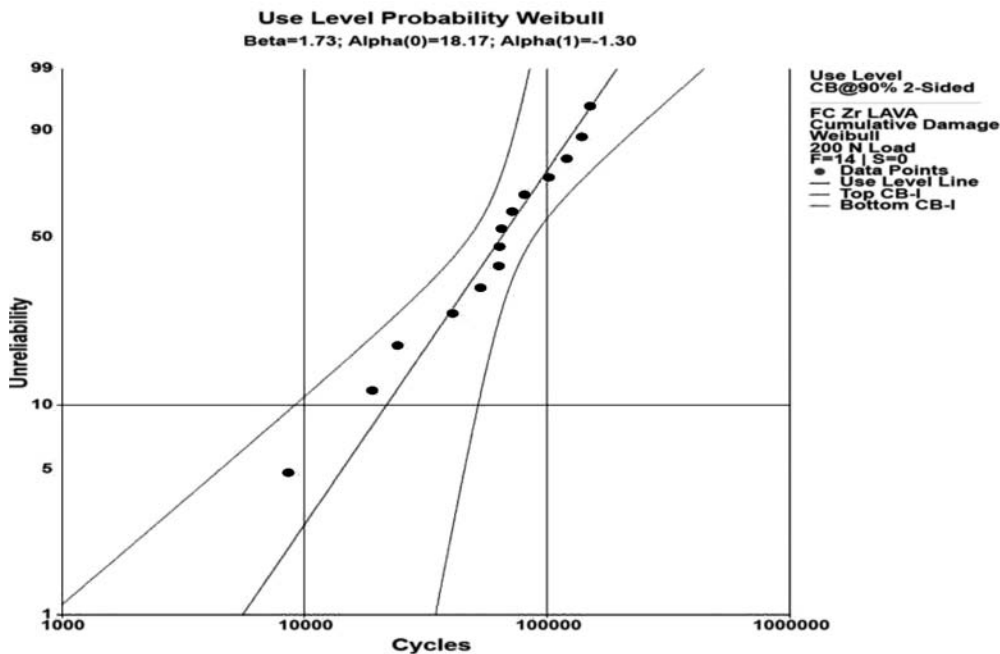
**Figure 4.** Weibull distribution graph for the Lava all-ceramic crowns depicts unreliability vs. number of cycles (90% two-sided confidence bounds) with a load of 200 N. Weibull modulus of 1.7 indicates that fatigue was not a strong accelerator of failure.

The observed step-stress-derived probability Weibull plot at a 200-N load resulted in a Weibull modulus of 1.7 (Fig. 4), which indicated that fatigue was not a strong acceleration factor and that failures would be distributed over a wide range of load cycles. Step-stress-accelerated fatigue studies facilitate estimates of reliability at a given load level. The calculated crown reliability with 90% confidence bounds for a 200-N load and a mission of 50,000 cycles was equal to 0.48 (0.68 - 0.25). This indicates that the cumulative damage from loads reaching 200 N would lead to veneer failure in over 50% of the specimens tested by 50,000 cycles.
